**File No.: HMT-MRA-BZFP-SB01**

**FRESH PRESERVATION  
PERFORMANCE EVALUATION OF  
BLUEZONE® FRESH PRESERVATION  
TECHNOLOGY**

**Headway Technology Co., Ltd.**

**April 2018**

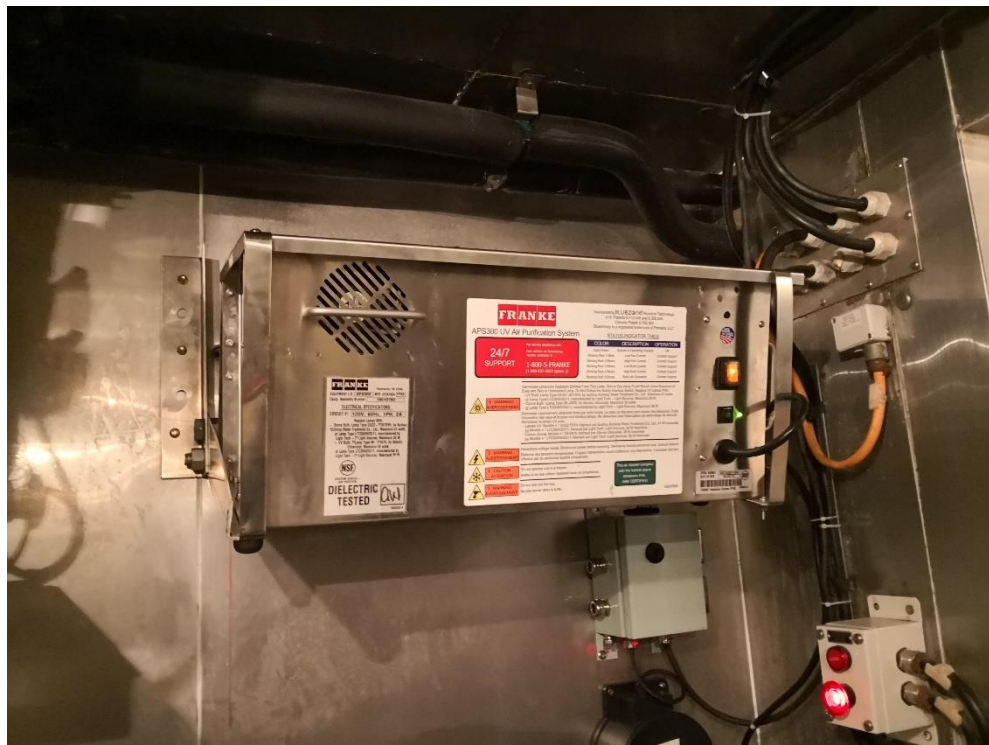
The vessel COSCO JUDA was equipped with three walk-in refrigerators separately for Fruit & Vegetable, Meat & Fish and Groceries. Each walk-in has independent temperature sensor that was displayed in kitchen. The BlueZone® Model 300 was installed in Fruit & Vegetable refrigerator, with an estimate volume of 65m<sup>3</sup>. The temperature of walk-in refrigerator was set at 4°C.

Figure 1 - BlueZone Model 300 on COSCO JUDA

BlueZone® Model 300 unit has been installed according to the instructions on User Manual under the supervision of Cheng'guo, Liu, Senior Engineer of Headway, to ensure a stable performance of the unit.

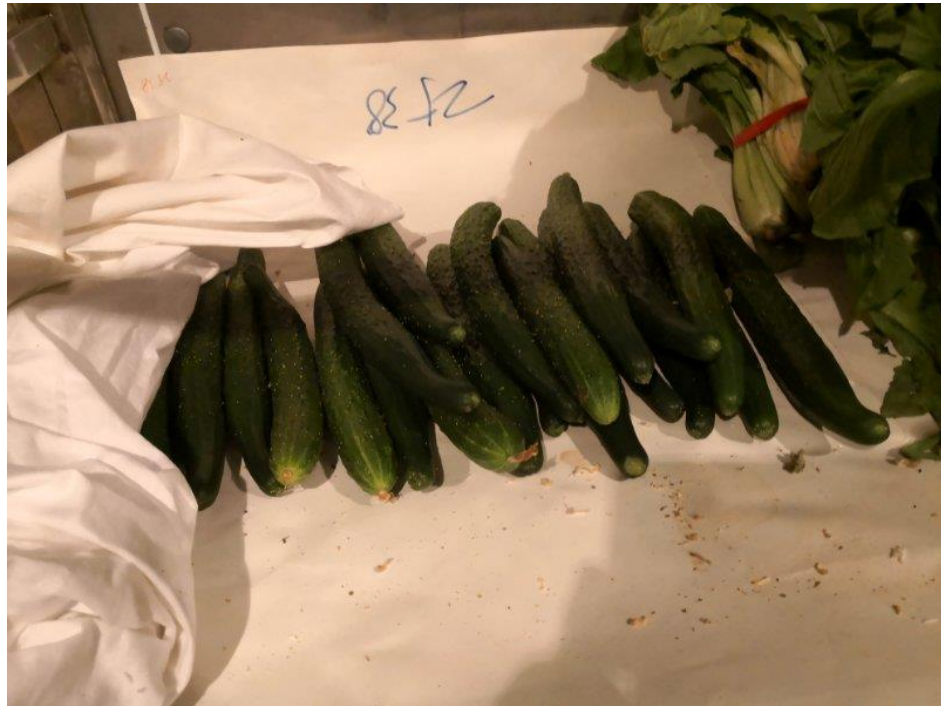
The cucumbers were in a solid state with good taste after 21 days of storage.

Figure 4 - Test 1\_Cucumber after D21

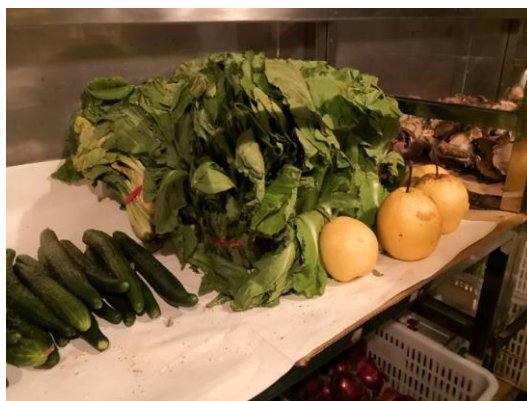
Figure 5 - Test 1\_Vegetable after D21

The vegetables were still in good condition, but the color of leaves has already start turning into yellow, they are still eatable. Based on the experience of chief, the freshness of vegetable can be rated 4 out of 5.

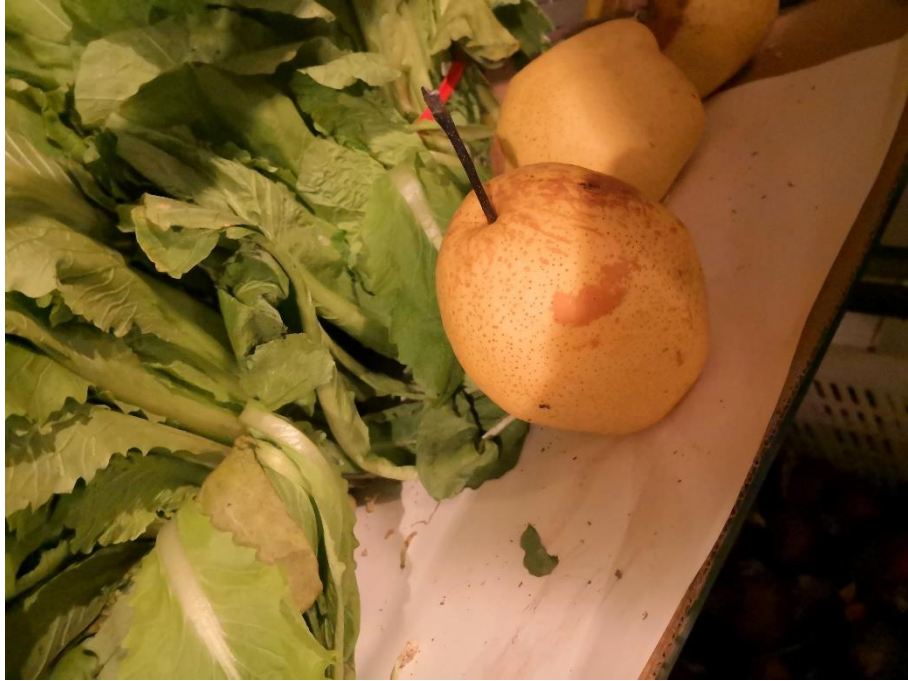
As for the pears, four pears were stored on the shelf, two of them were in good condition, with a freshness rated 4 out of 5. The other two was partly rotten. Based on the observation onsite, the rotten part was the contact surface of two neighbor pears. Therefore, Headway engineer draw a basic

Figure 7 - Test 1\_Pears after D21

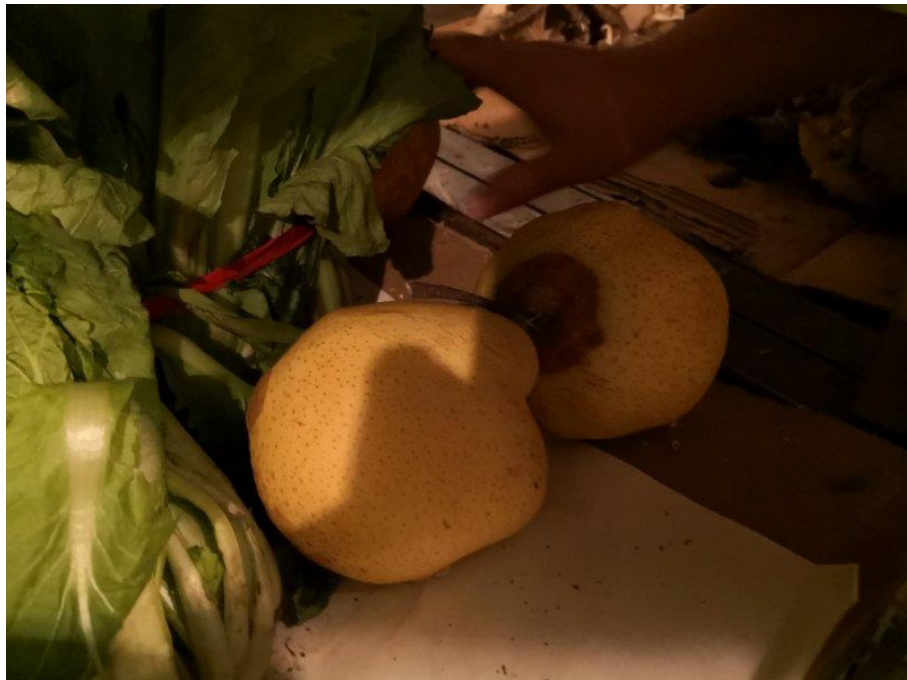
conclusion the rotten was caused by the lack of contact with treated air.

Figure 6 - Test 1\_Rotten Part of Pears

It is also observed that the fresh fruit are often rotten on the side that in contact with the container. Therefore, it might improve the performance of the unit if a special designed container with maximum contact of air was applied to FF&V.

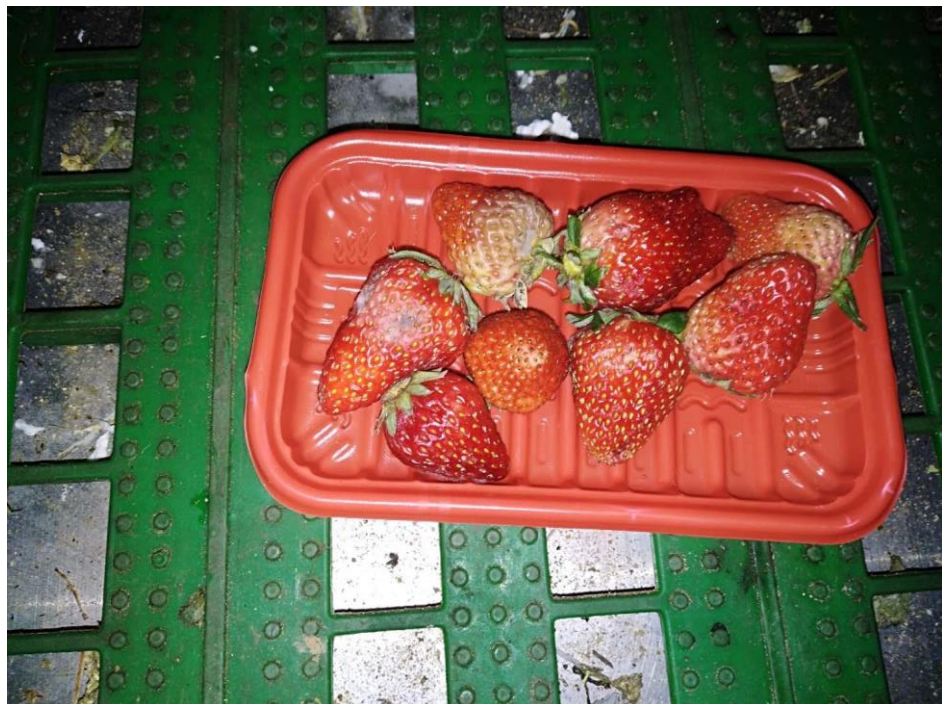
The strawberry stored in walk-in refrigerator starting to turn color white on day 2 stored and shown serious mold and rotten on day 3 All strawberries were disposed after day 5 due to rotten.

Figure 8 - Test 2\_Strawberry on Day 2

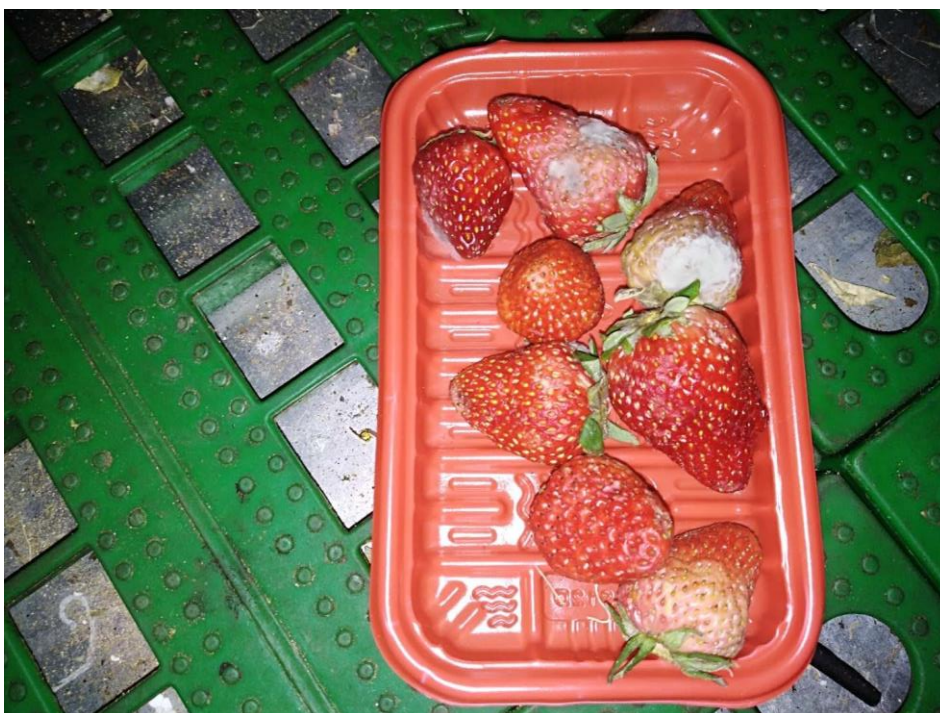
Figure 9 - Test 2\_Strawberry after D3

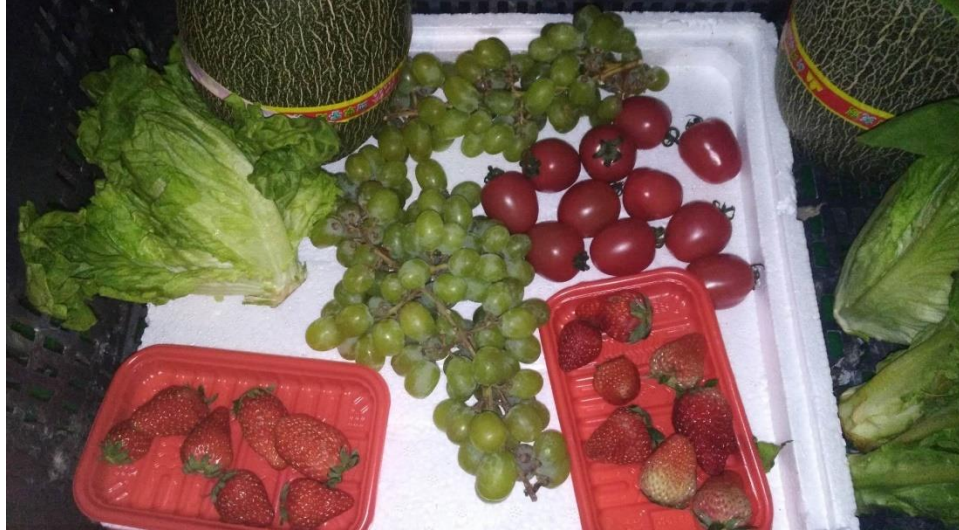
Figure 10 - Test 3\_D4 FF&V

All FF&V were perfectly fresh on day 4, while strawberries has already rotten on day 4 in test 2.

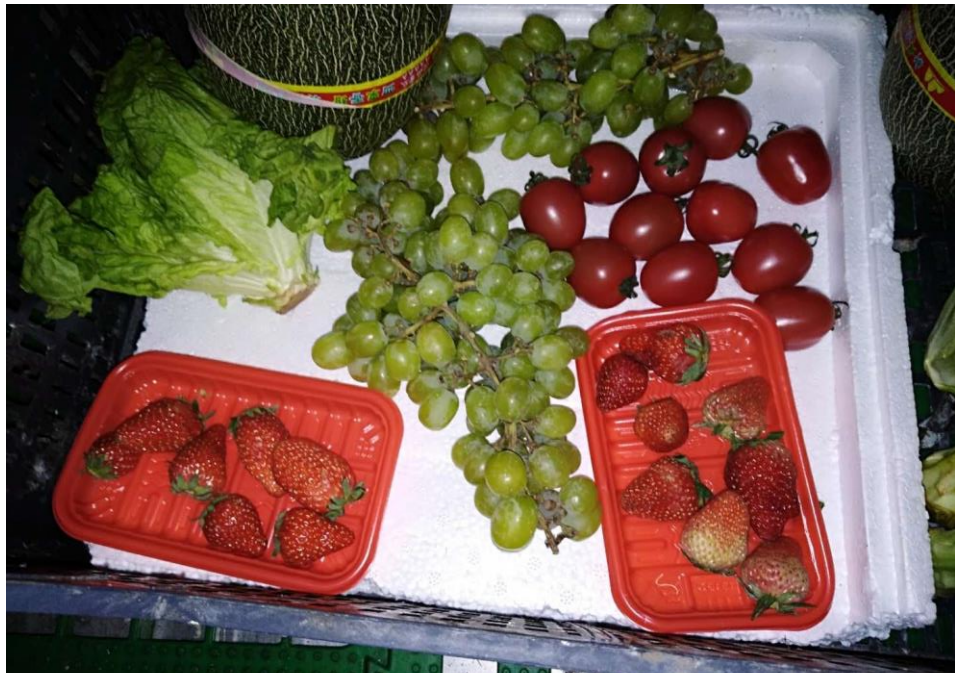
Most FF&V are still in very good fresh. Two of the strawberries got mold spot on the surface.

Figure 11 - Test 3\_D 6 FF&V

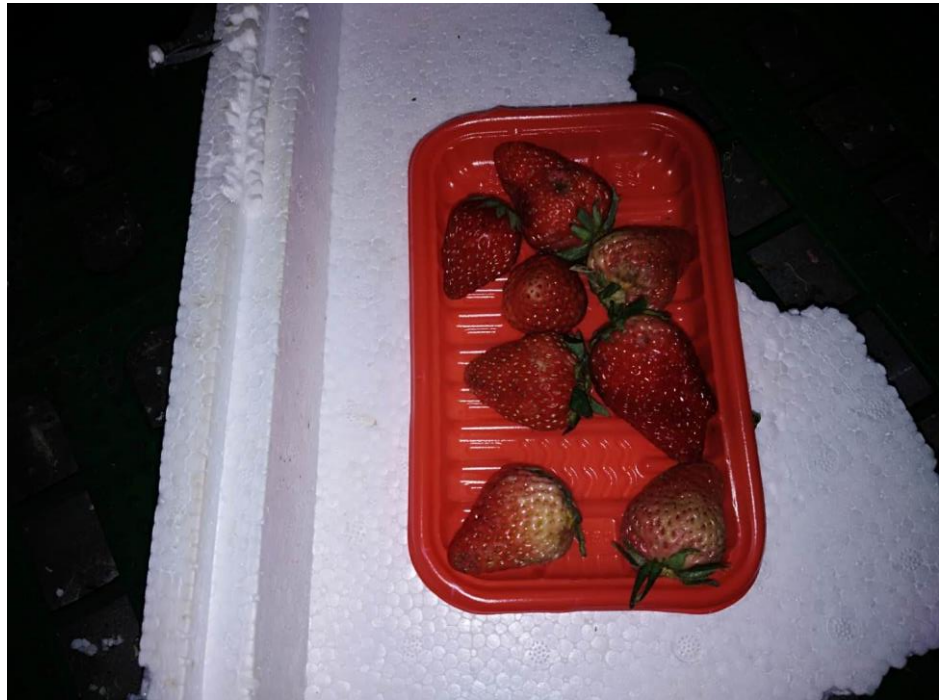
Figure 12 - Test 3\_Mold Spot of Strawberry

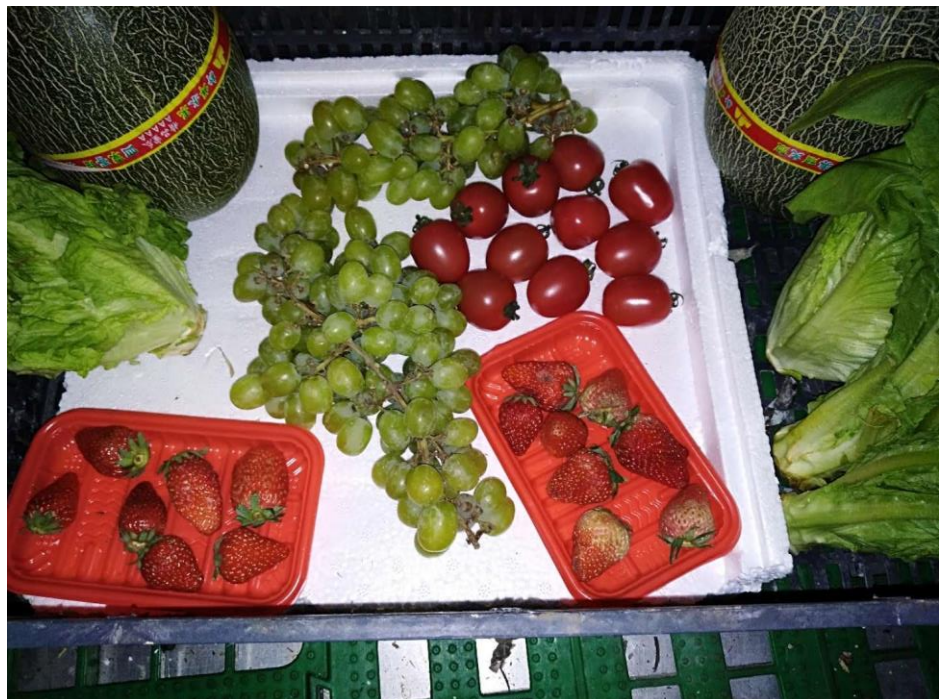
One box of strawberry has shown massive mold spot. Chief has considered them were starting rotten

Figure 13 - Test 3\_D9 Strawberry Start Rot

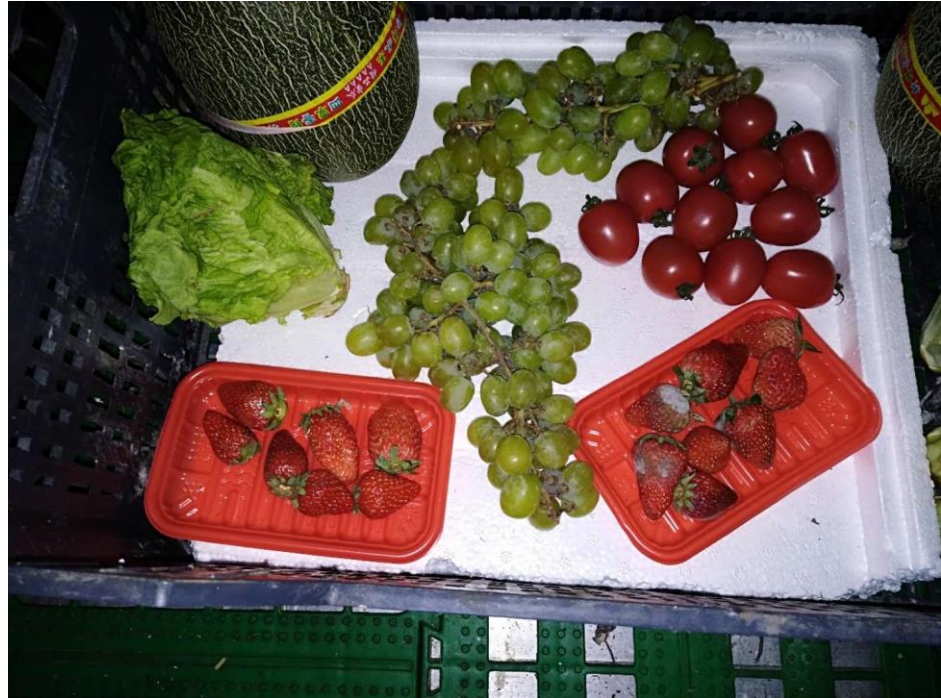
The strawberries which started rot has gone worse, while there still are some more strawberry that was in very good condition.

Figure 14 - Test 3\_D11

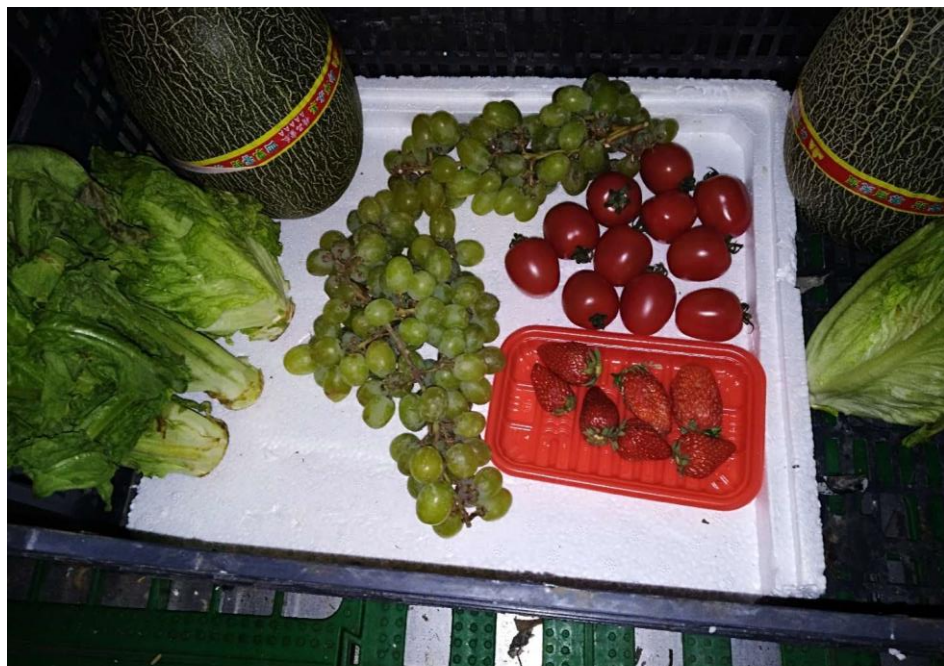
Half of the strawberry has gone rotten and has been disposed. The rest of the strawberries were still in good condition. Lettuce started shown black

Figure 15 - Test 3\_D13

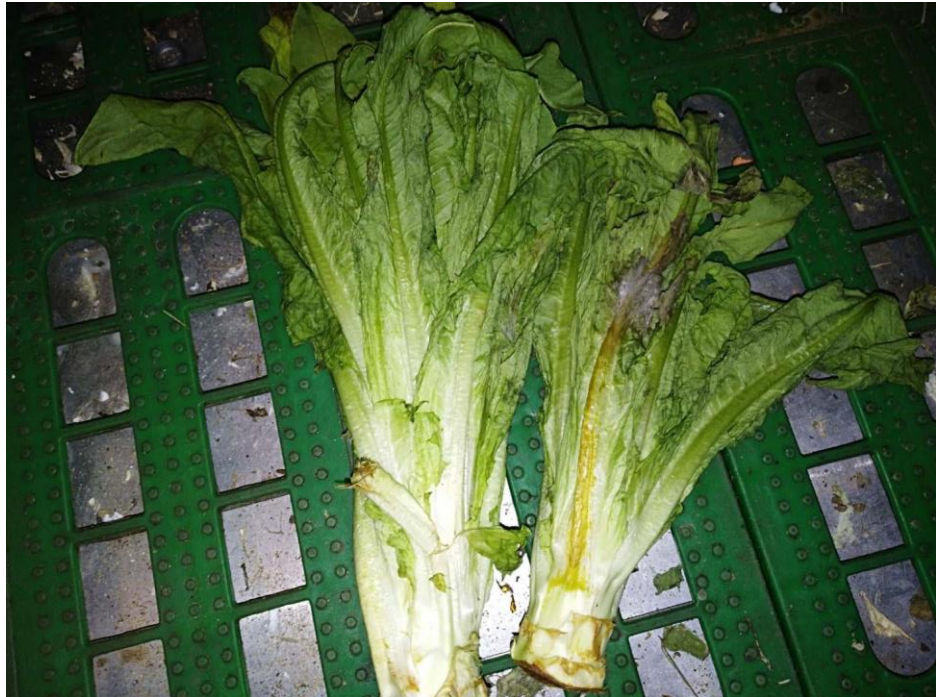
lining on leaves. Lactucas start turning into color yellow, with leaves start rotting.

Figure 16 - Test 3\_D13 Lactucas

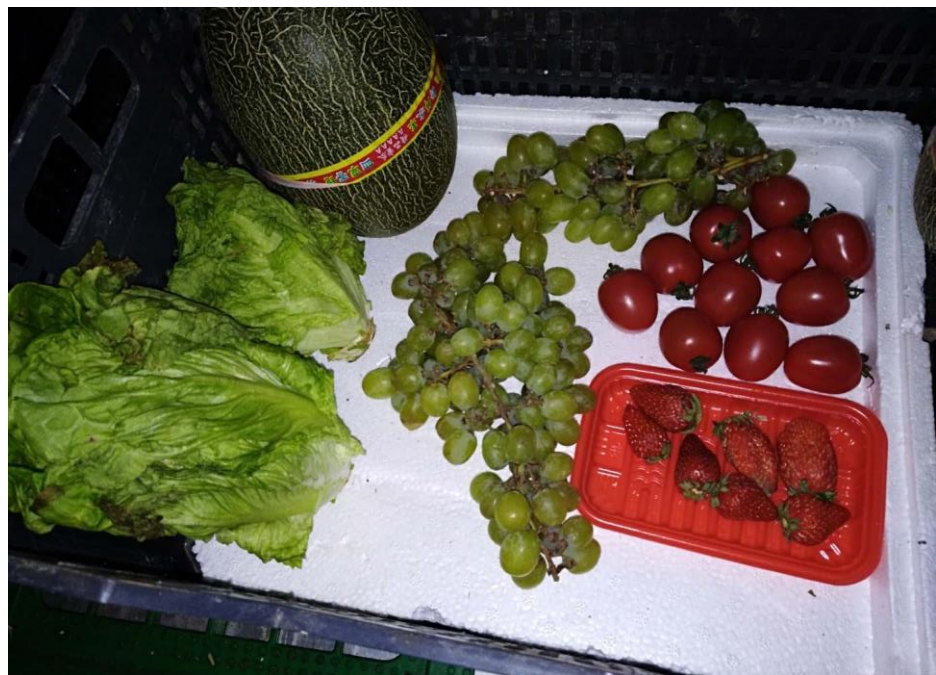
The rest of strawberries has gone rotten on the surface that was in contact with the container. All strawberries have been disposed by chief. The black lining of lettuce has gone worse.

Figure 17 - Test 3\_D16

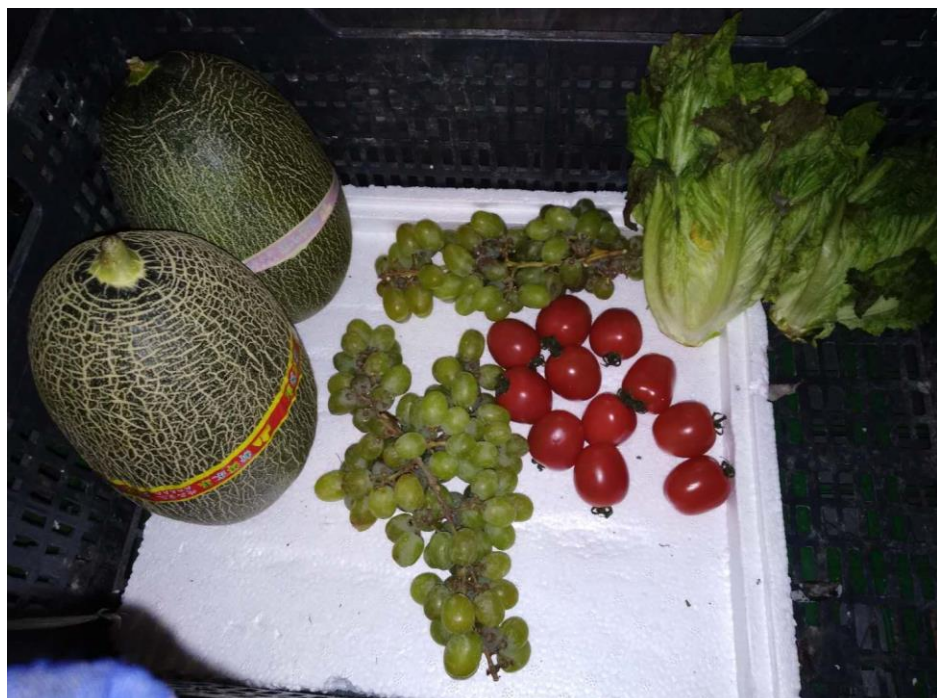
One bunch of grapes has serious rotten, lettuce was also considered “not eatable” due to large part of rot. Both Lettuce and the rotten brunch of grape were disposed.

Figure 19 - Test 3\_D19

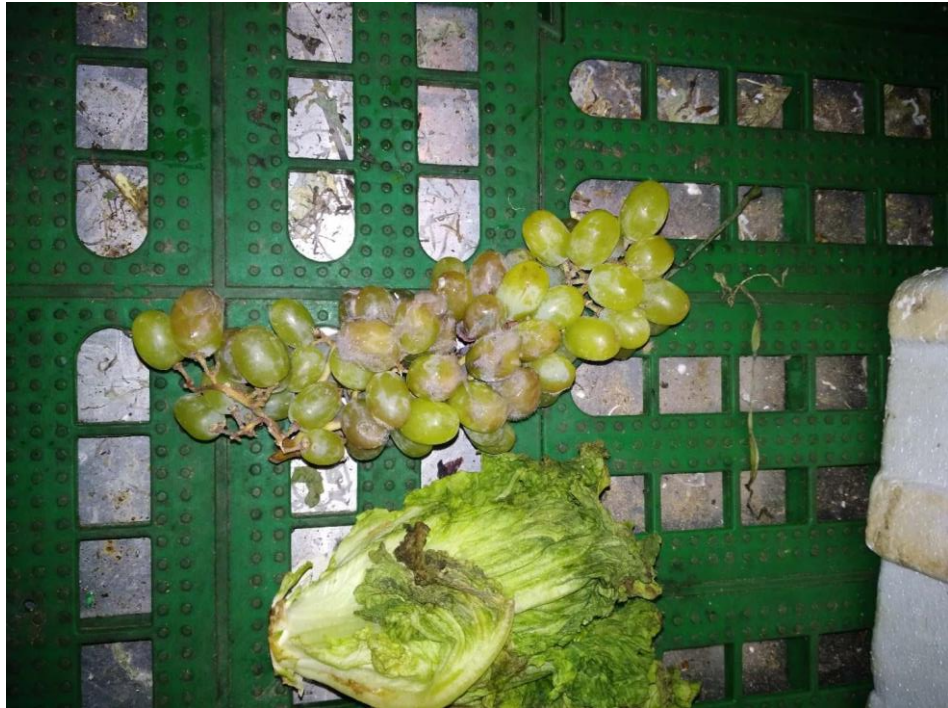
Figure 20 - Test 3\_D19 Rotten Grape

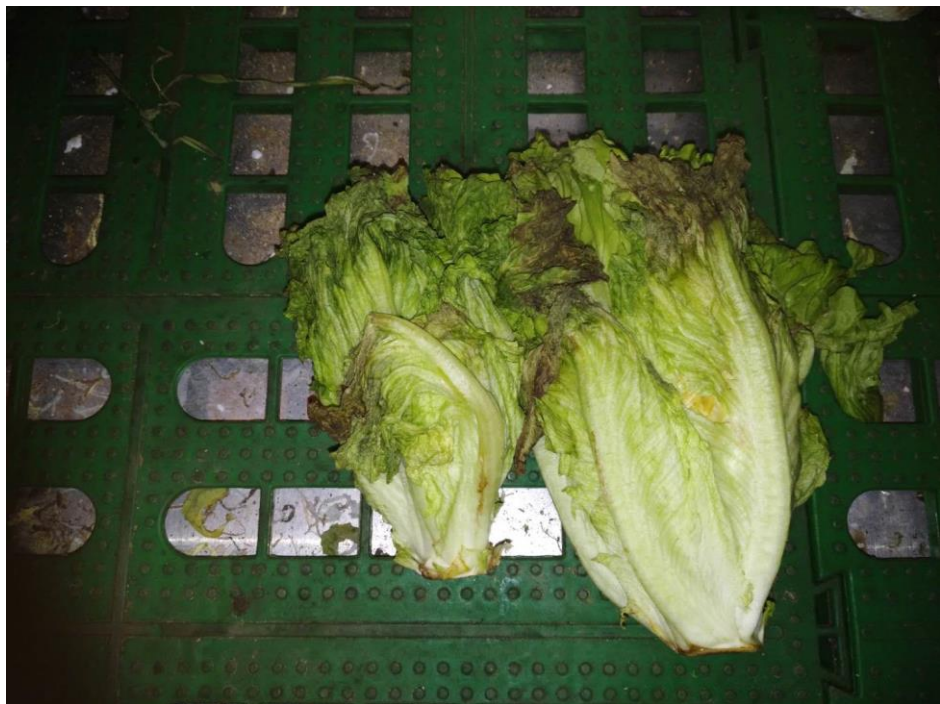
Figure 21 - Test 3\_D19 Rotten Lettuce

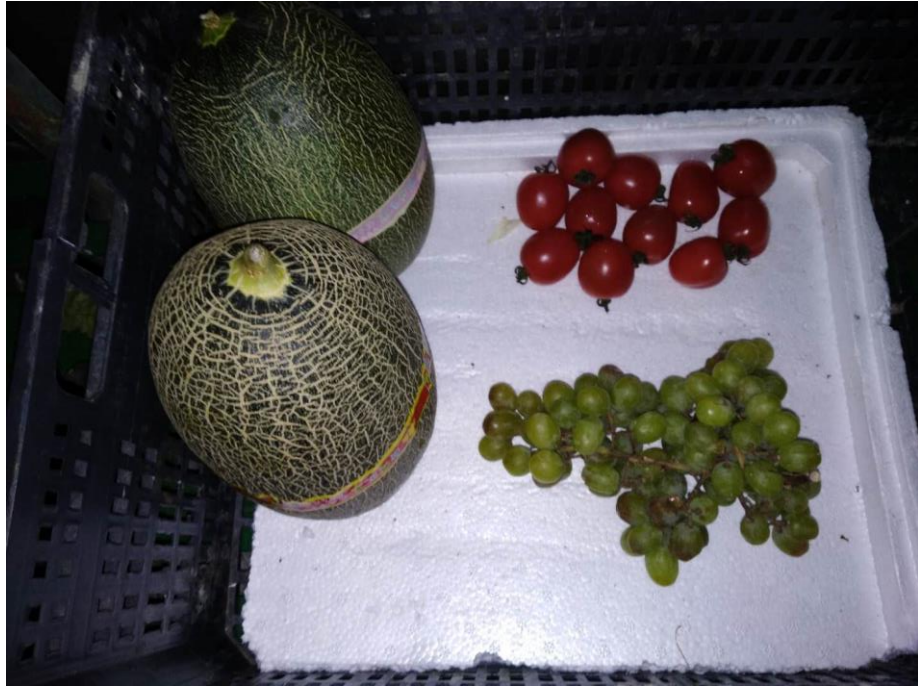
The other bunch of grape has gone partly rotten, most of grapes has lost the sphere shape and shown listless, chief has consider the grape “not eatable” and disposed them.

Figure 22 - Test 3\_D22

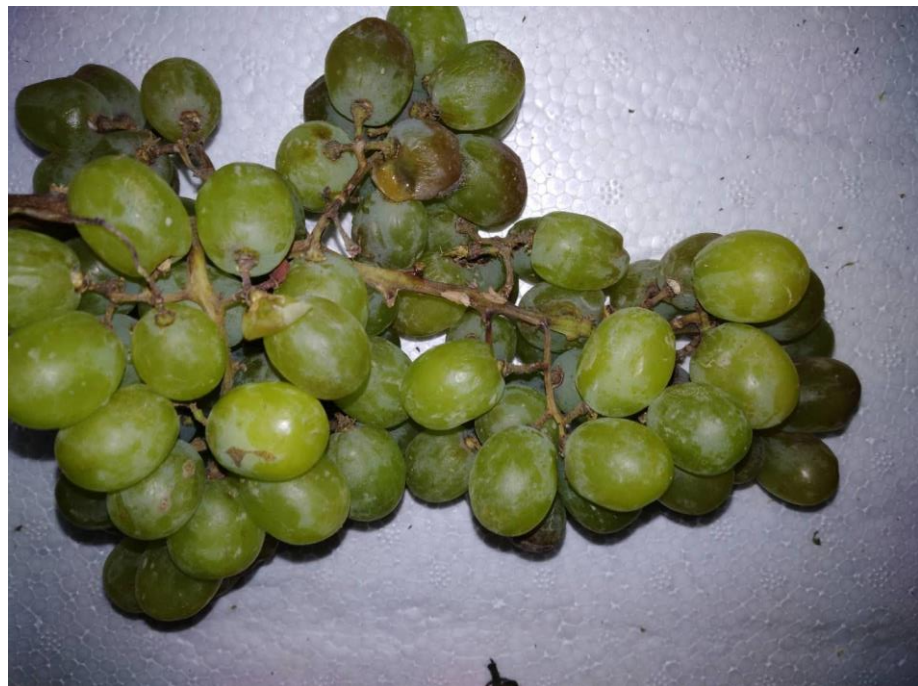
Figure 23 - Test 3\_D22 Rotten Grape

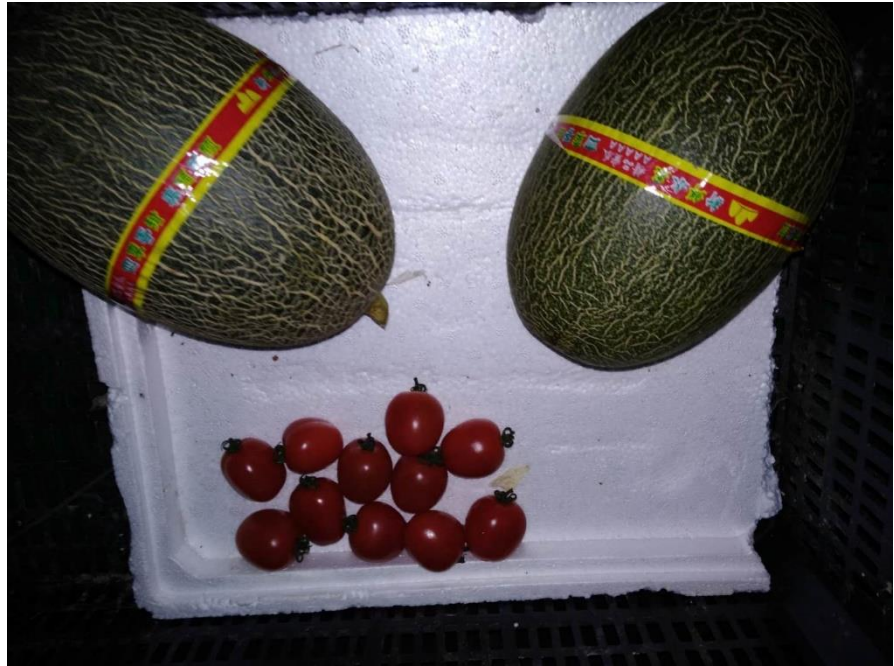
Both cantaloupe and cherry tomato were in perfect shape and have no change. The ship finished the trip from Indonesia on 1<sup>st</sup> April (D27). Both cantaloupe and cherry tomato stayed good condition during the trip.

Figure 24 - Test 3\_D27
